# IMPIANTO SPORTIVO LAURO GROSSI: RIFACIMENTO MANTO PISTA ATLETICA

MANUTENZIONE STRAORDINARIA  
CUP:I92H23000780004  
CUI:L00162210348202300061

# TRACK TEST REPORT

<b>Field Reference</b>	Stadio di atletica Lauro Grossi
<b>Field Address:</b>	via Po 43125, Parma Parma Italia
<b>Report Number:</b>	61831 / 1922
<b>Report Status:</b>	FINAL
<b>Issue Date:</b>	14/11/2024
<b>Client:</b>	Comune di Parma Strada della Repubblica, 1 43121, Parma Parma Italia

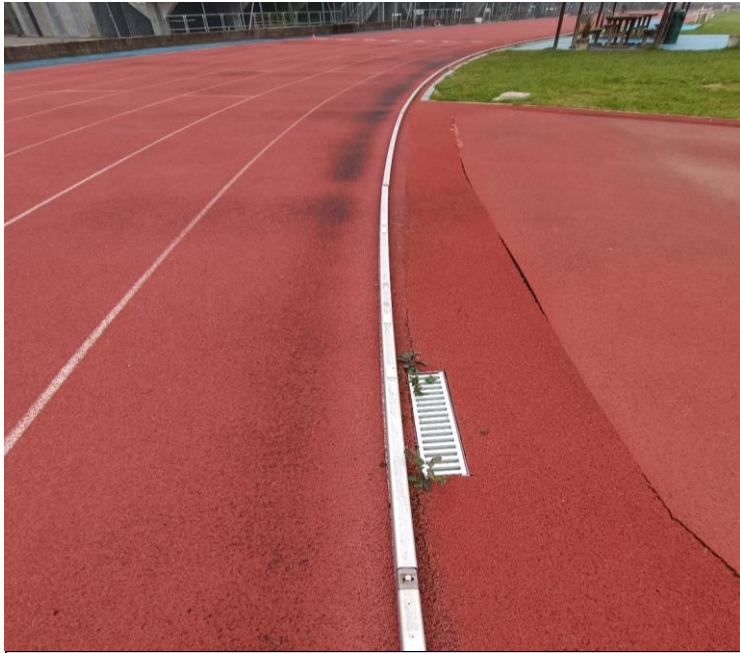
Property	Condition
Visual Inspection	Aesthetics	Aree di delaminazione	Nessuna lungo l'anello
		Giunte	Buone condizioni
		Tracciature	Segni di degradamento diffusi
		Colore	Inconsistente, strato di gomma nera visibile su gran parte della pista
		Attrezzature e recinzioni	Presenti
		Manutenzione (sporczia, ecc.)	Impianto pulito

Corsia 1 Molto consumata
