# IMPIANTO SPORTIVO LAURO GROSSI: RIFACIMENTO MANTO PISTA ATLETICA

MANUTENZIONE STRAORDINARIA  
CUP:I92H23000780004  
CUI:L00162210348202300061

# TRACK TEST REPORT

<b>Field Reference</b>	Stadio di atletica Lauro Grossi
<b>Field Address:</b>	via Po 43125, Parma Parma Italia
<b>Report Number:</b>	61831 / 1922
<b>Report Status:</b>	FINAL
<b>Issue Date:</b>	14/11/2024
<b>Client:</b>	Comune di Parma Strada della Repubblica, 1 43121, Parma Parma Italia

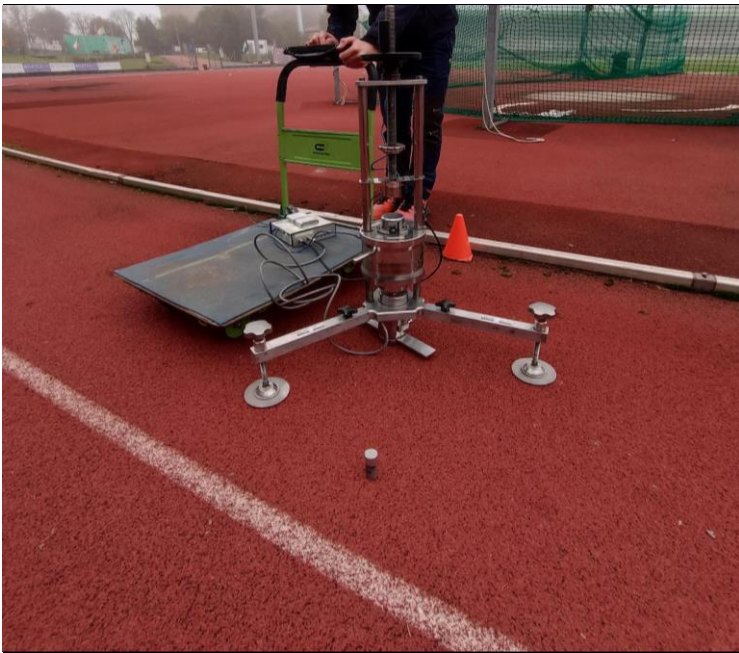
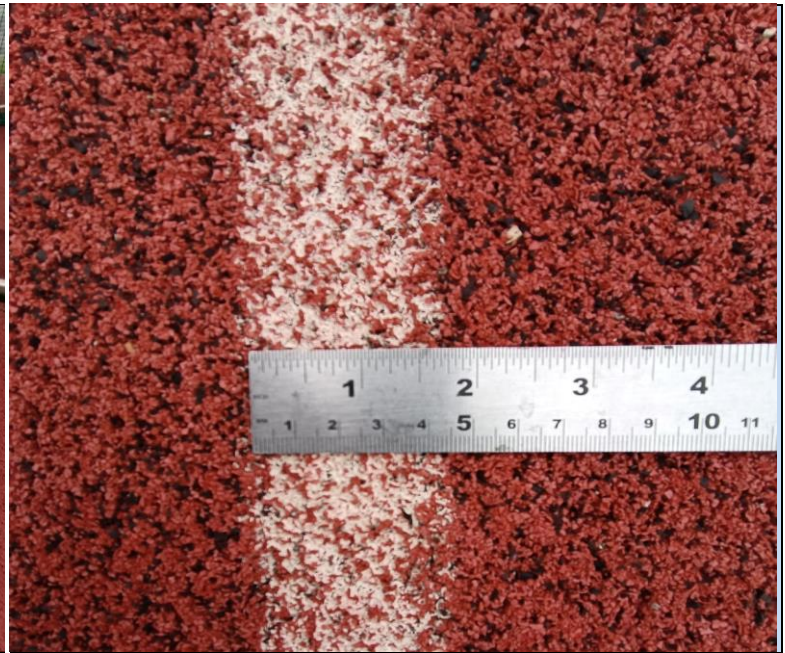
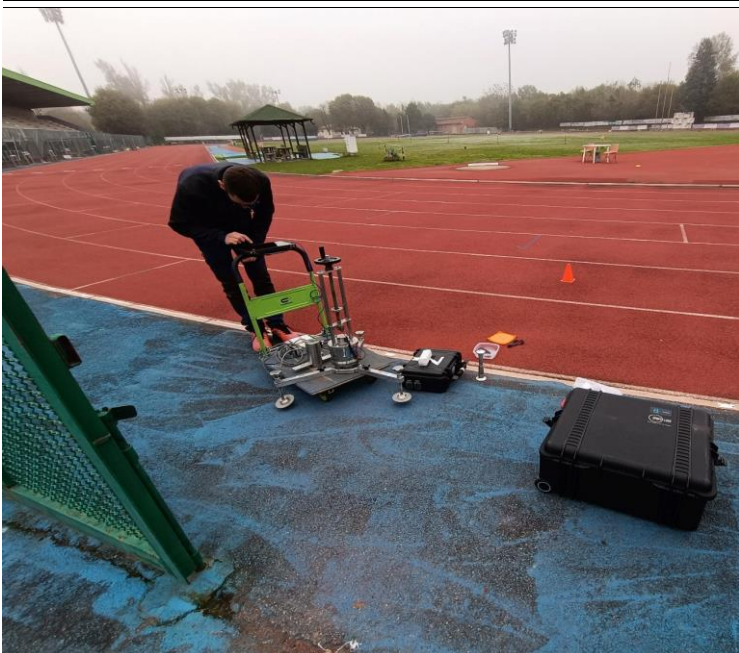
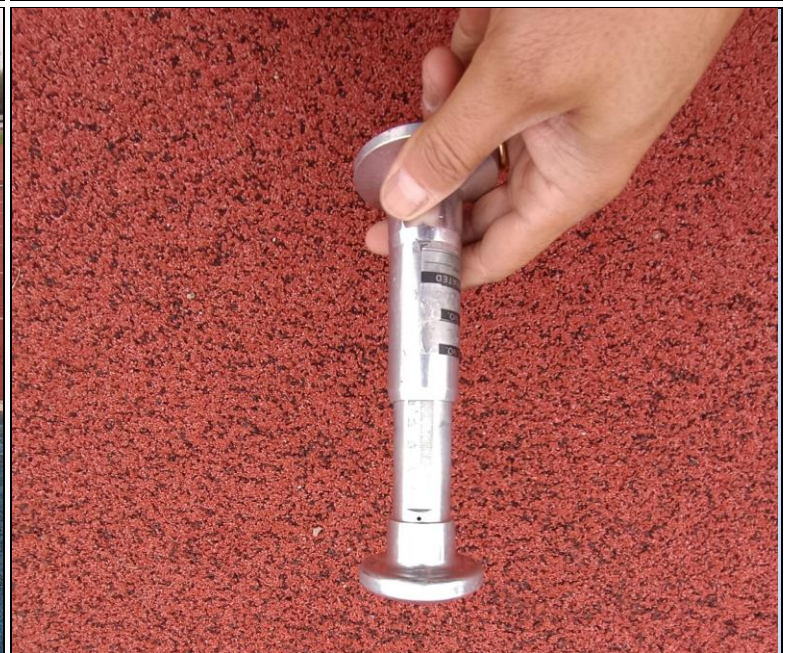
Property	Condition
Visual Inspection	Aesthetics	Aree di delaminazione	Nessuna lungo l'anello
		Giunte	Buone condizioni
		Tracciature	Segni di degradamento diffusi
		Colore	Inconsistente, strato di gomma nera visibile su gran parte della pista
		Attrezzature e recinzioni	Presenti
		Manutenzione (sporczia, ecc.)	Impianto pulito
